Out of sight, out of mind

Words: Laura Hall, Senior Marketing & Communications Manager and Charlie Watt
Business Development Manager at EasyQote

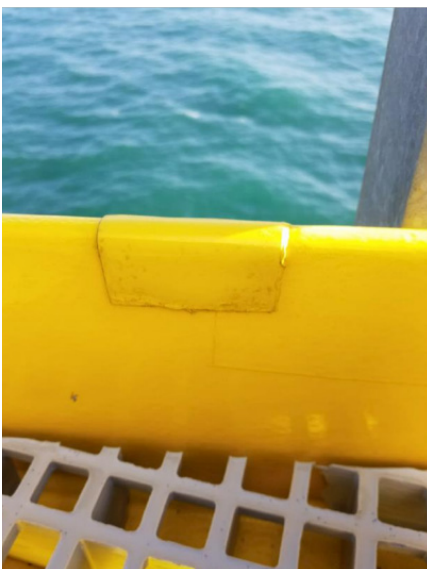
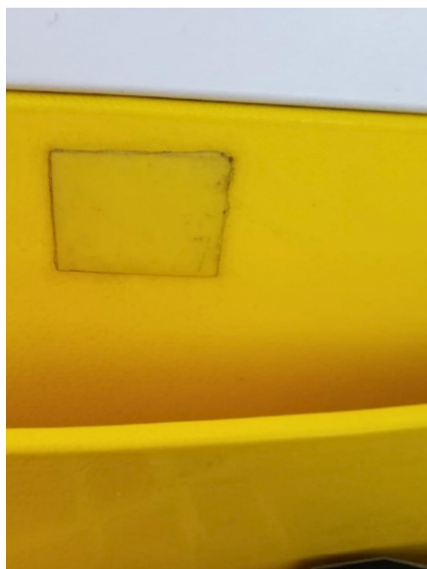
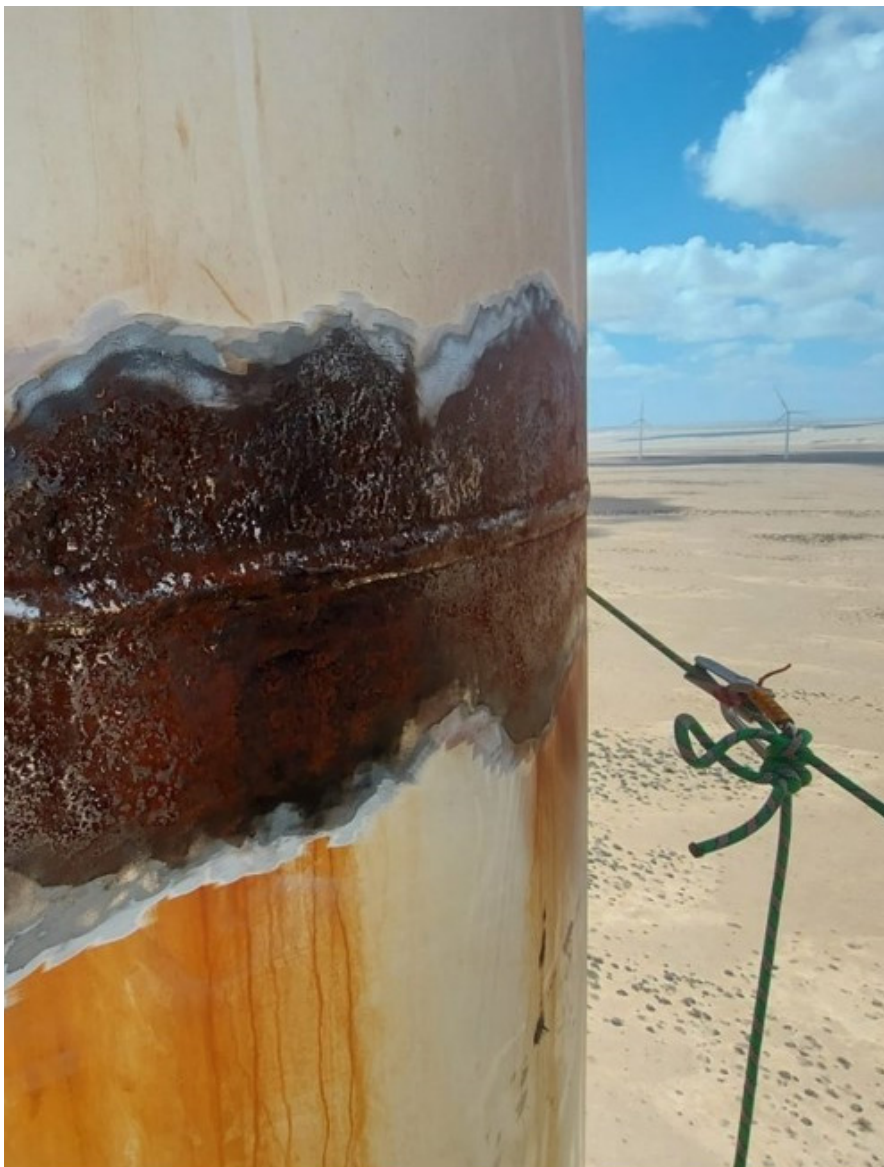
In 2016, EasyQote yellow self-cleaning patches were installed offshore in the North

Sea on damaged wind turbine foundations. The pictures you can see here were taken in 2022, when the site was revisited. As you can see, the self-cleaning patches are as good as the day they were installed, with no UV degradation.
